DayCor® ROM

Corona Inspection Airborne Solution

DayCor[®] ROM

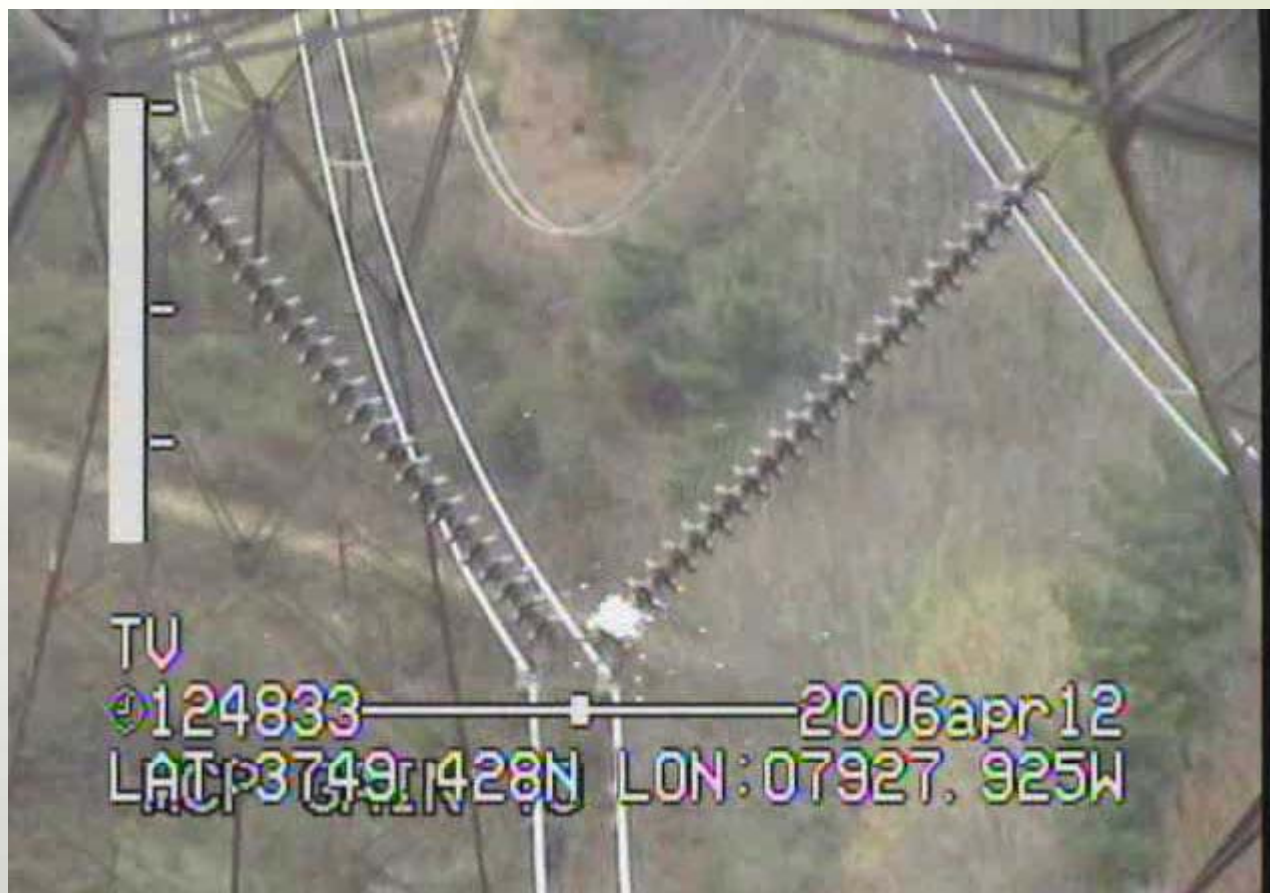
Multi spectral inspection

Toggle between Corona/Visible

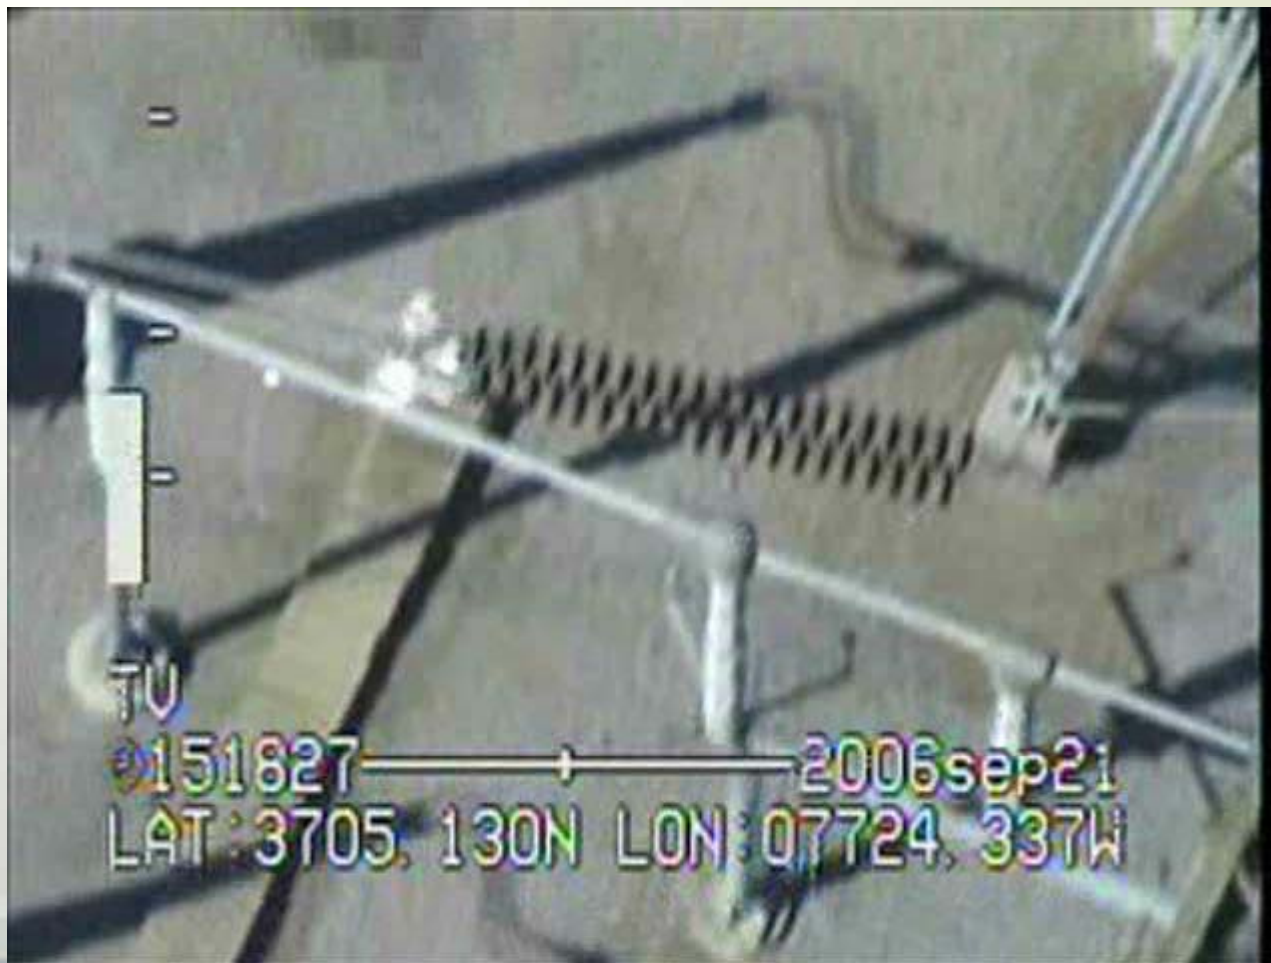
Multi spectral inspection

Toggle between Corona/IR

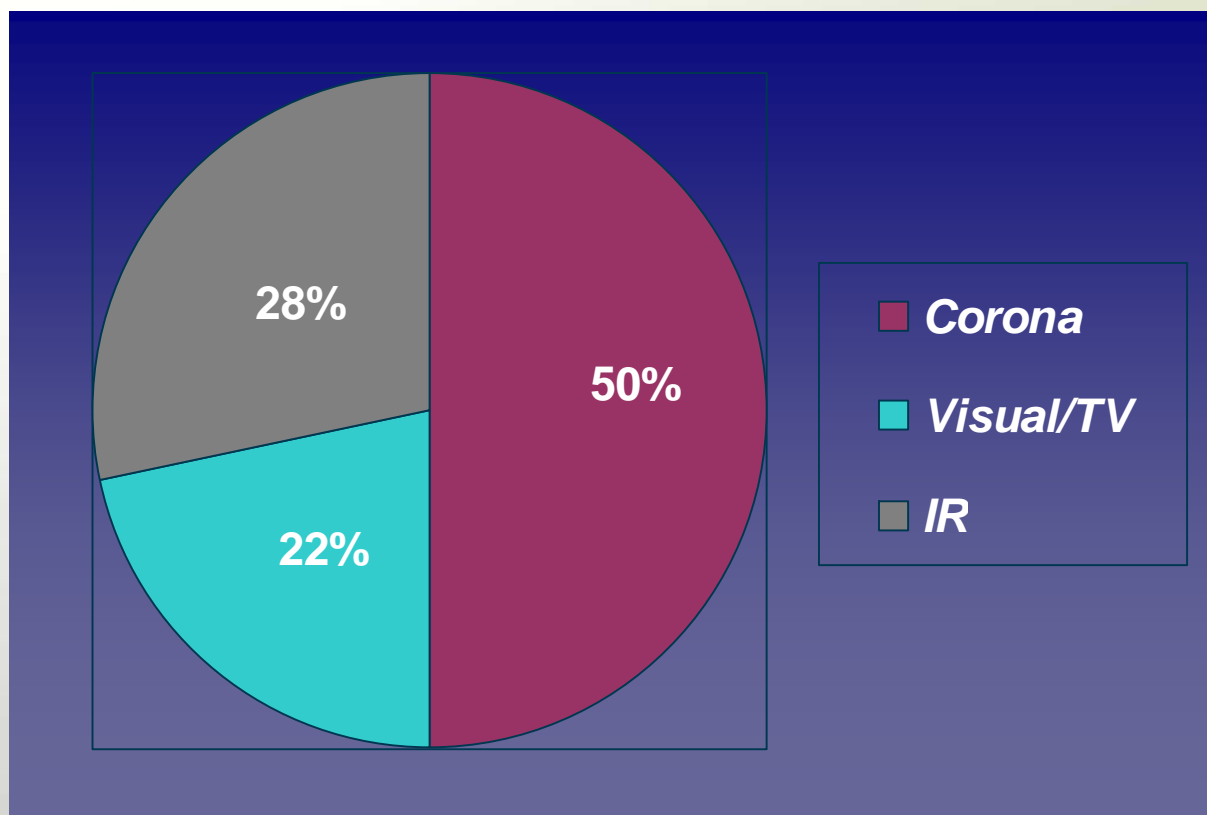
Multi spectral inspection

Percentage Of Problems Found By Cameras

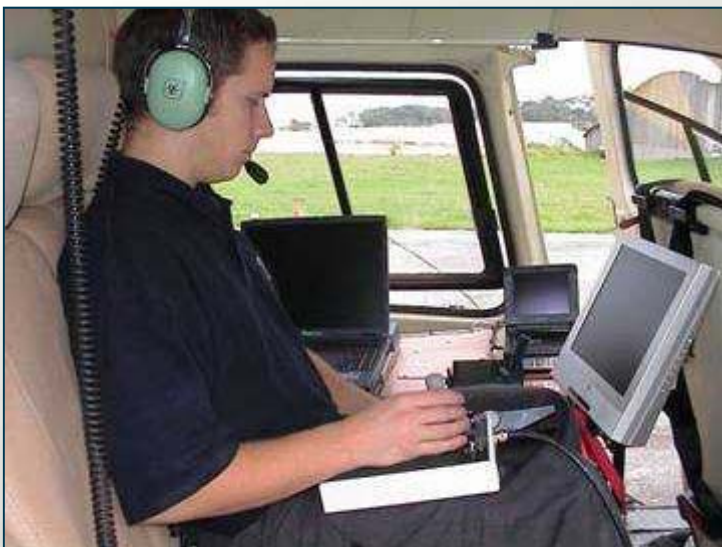
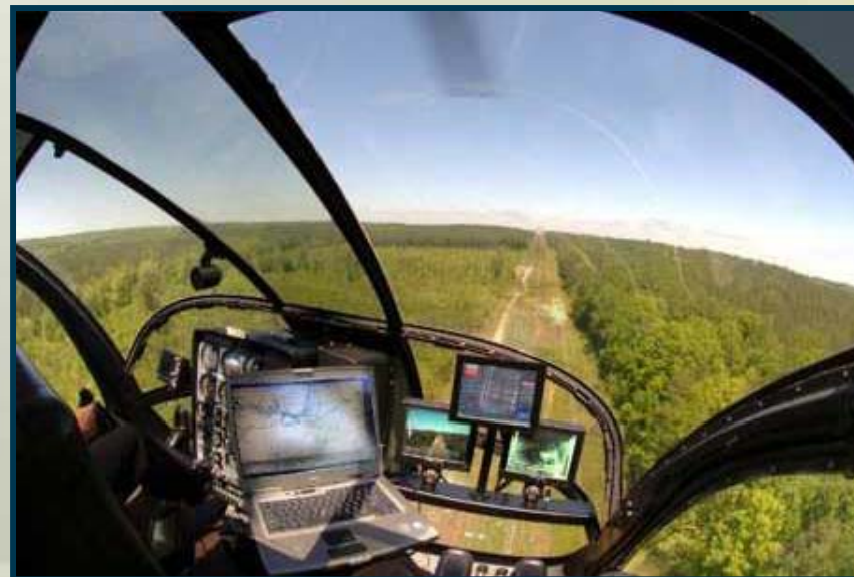
Professional & accurate

Gyro stabilized gimbaled payload

- Stabilization of 100 micro radian
- GPS based
- High backlit screens at the observers station
- Flight without topographic limitation
